# Damming a bedrock cut to daylight a buried stream under an abandoned railroad crossing in the Eel River Canyon of northwest California

# Damming a Bedrock Cut to Daylight a Buried Stream

Woodman Creek, Eel River Canyon, NW California

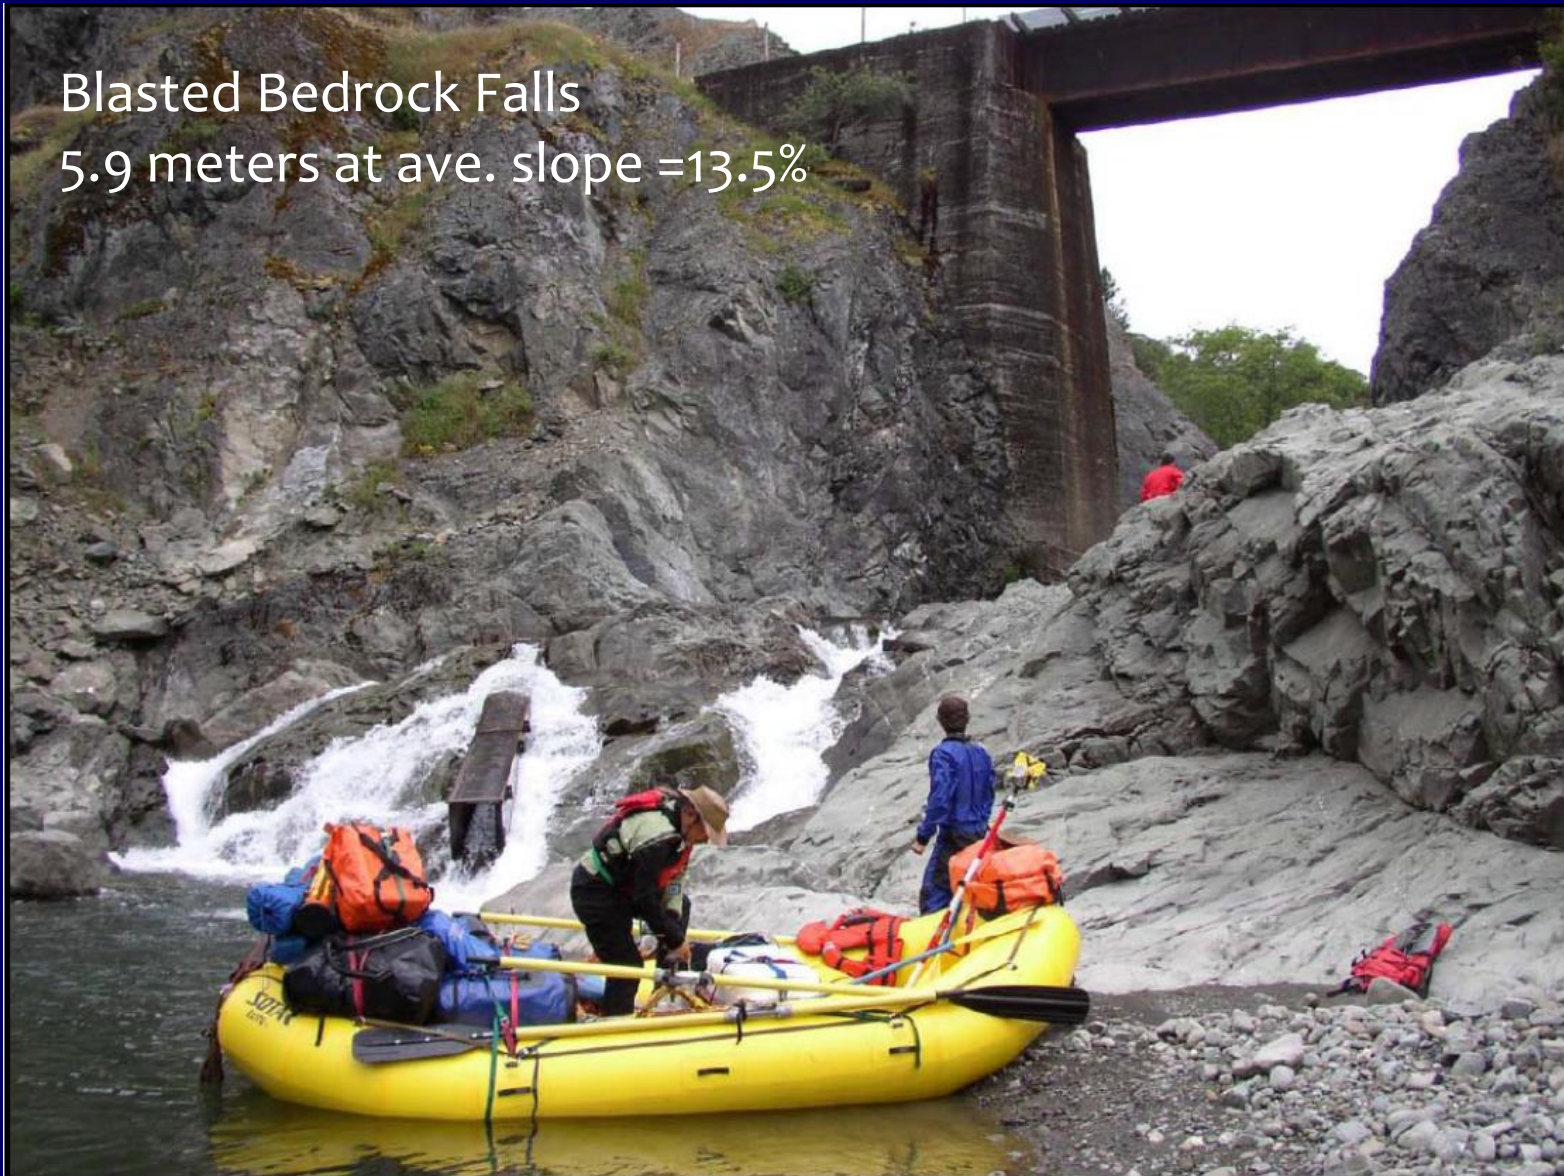
# Dilapidated and Ineffective Denil Fish Ladder at Bedrock Cut

Blasted Bedrock Falls  
5.9 meters at ave. slope = 13.5%

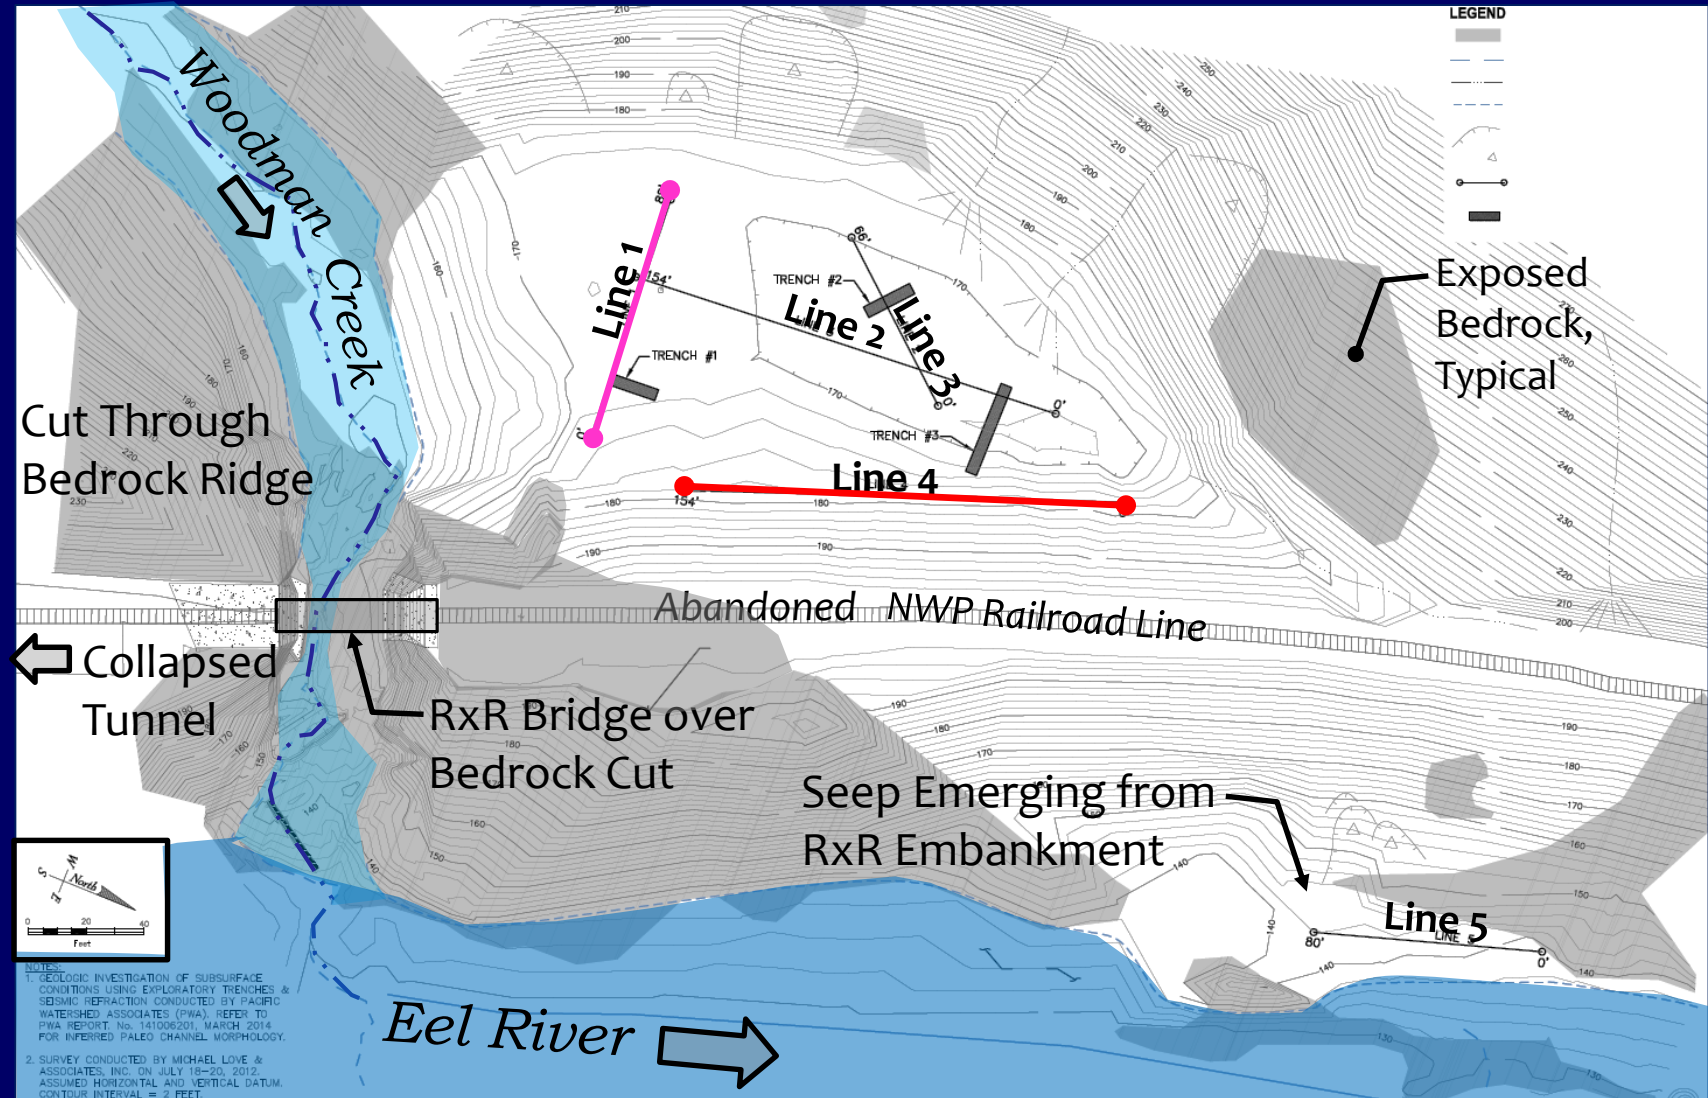
# Topographic Survey and Subsurface Investigations

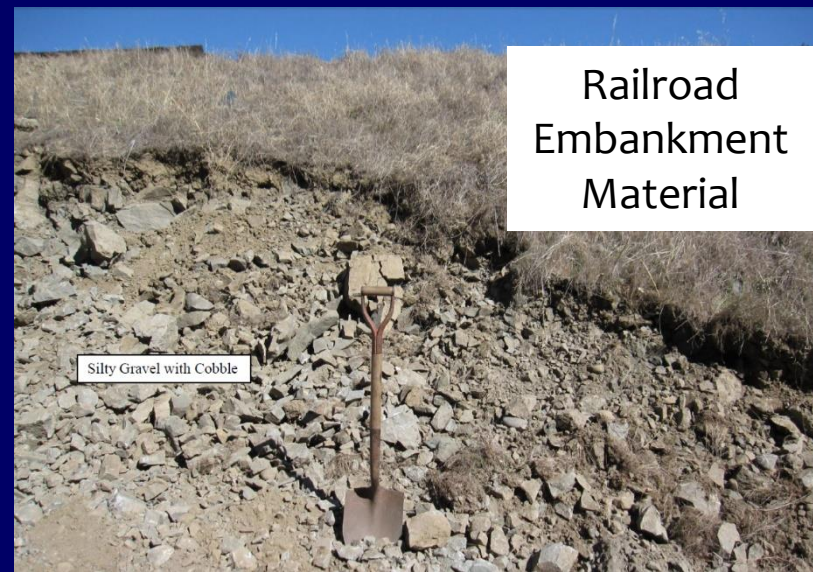
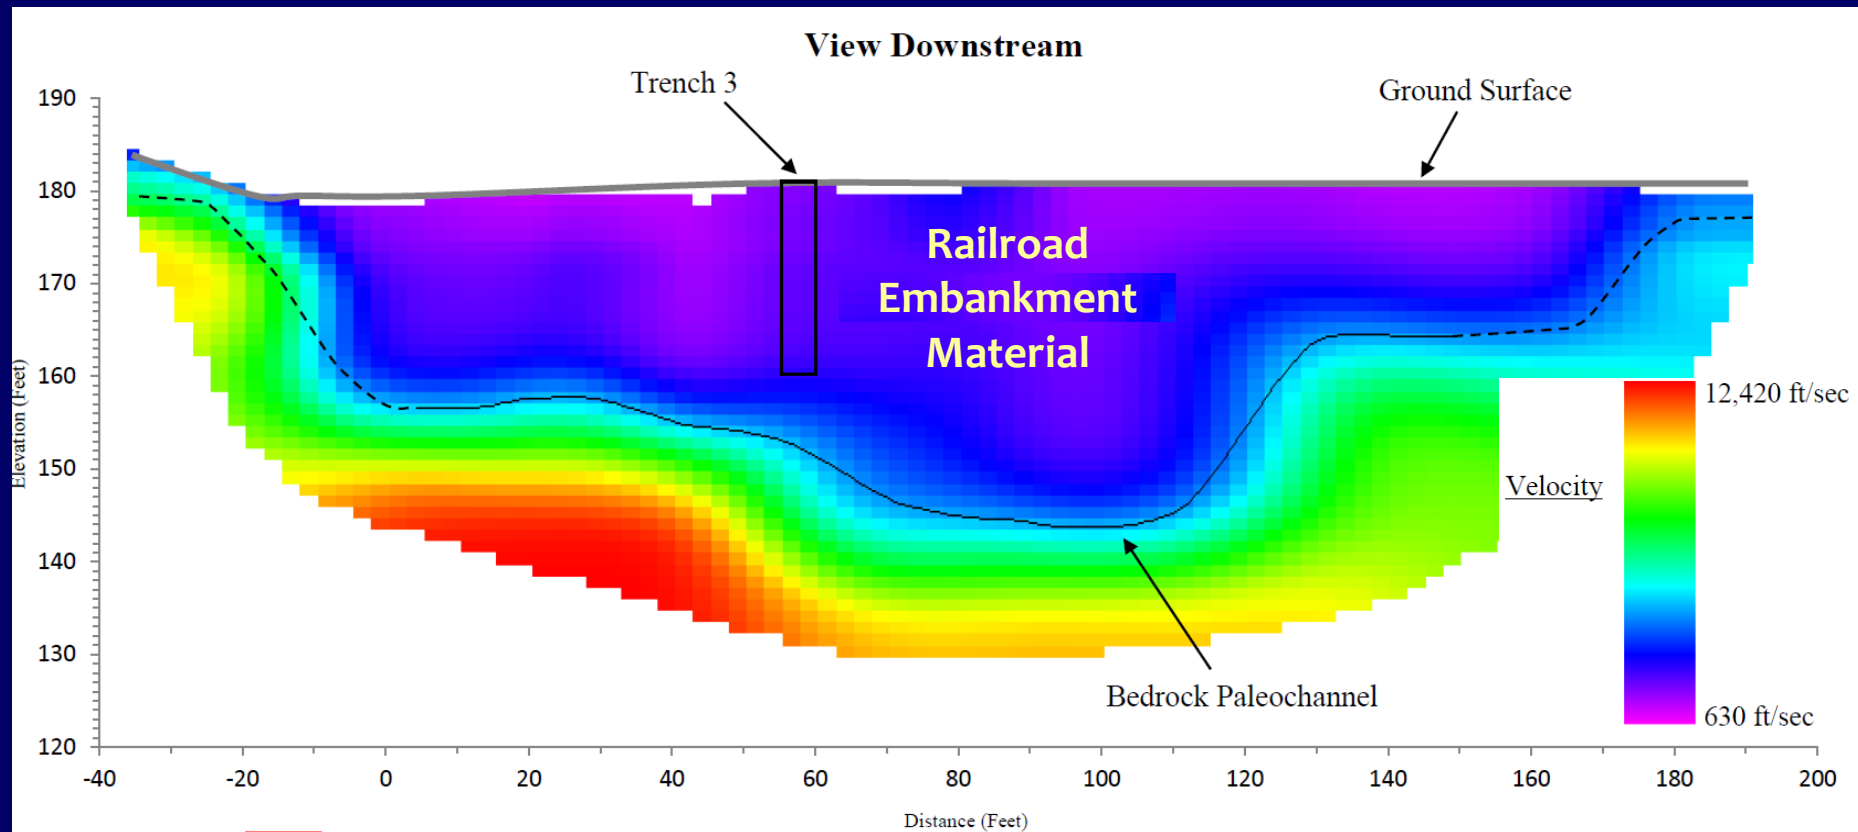
# Refraction - Line 4

## Along Exposed Toe of RxR Embankment Perpendicular to Buried Channel

Slackwater  
Deposits

Silt with Sand (Slackwater Deposits)

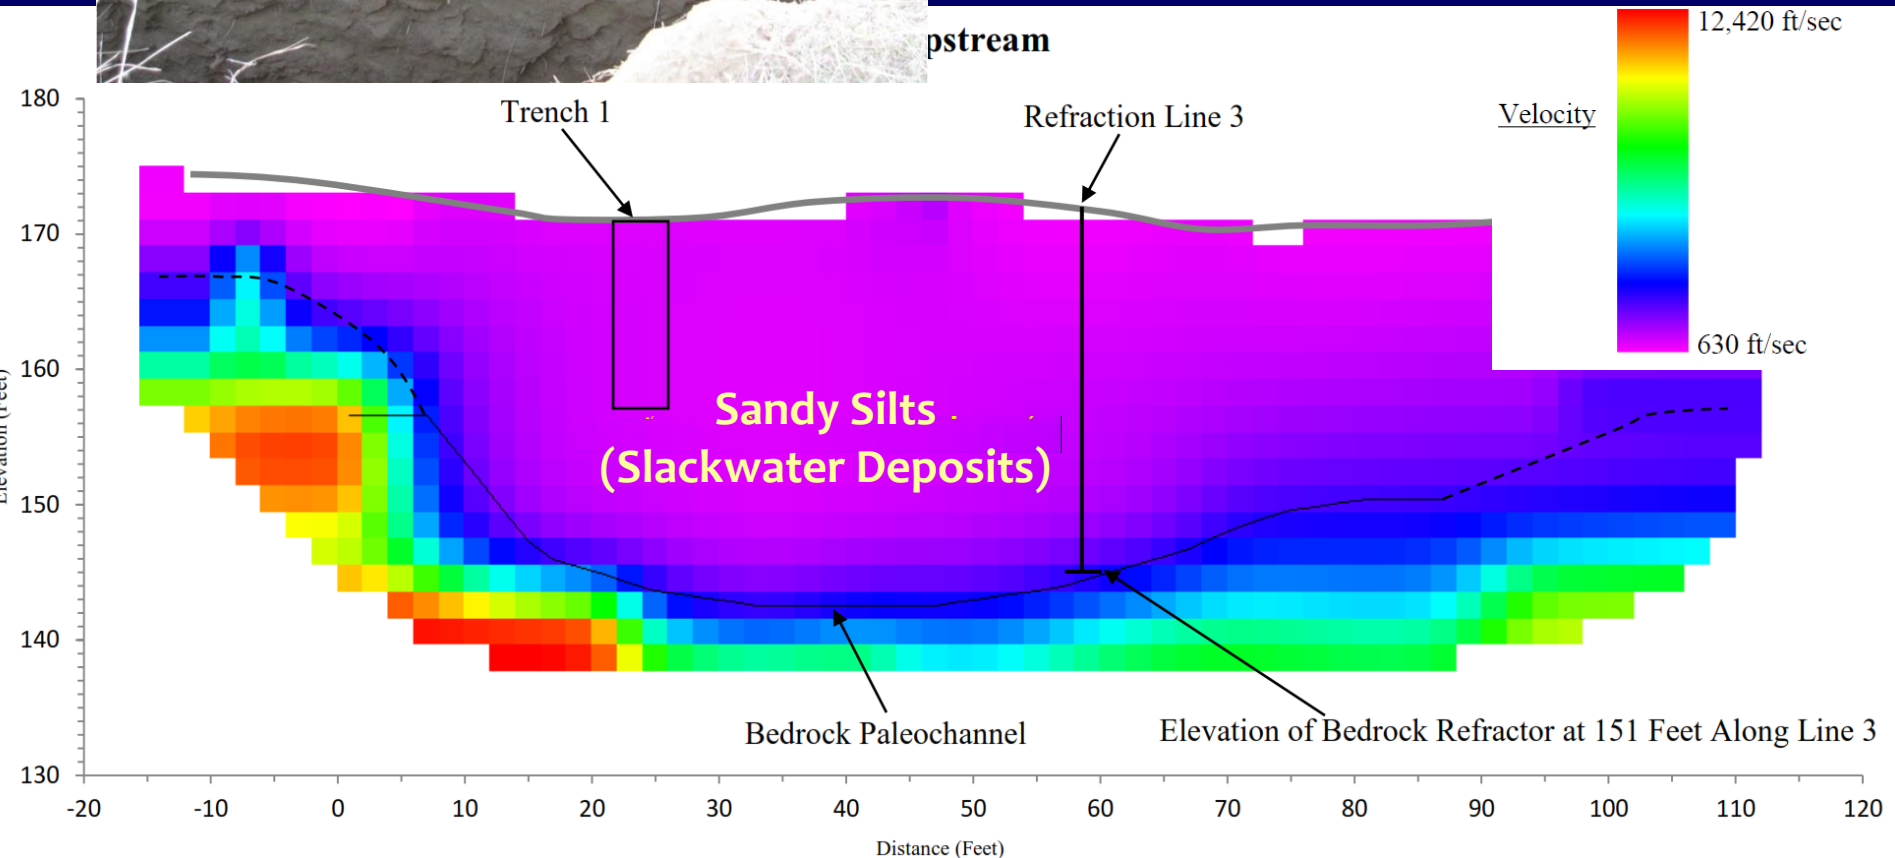
# Refraction - Line 1

## Perpendicular to Buried Stream Channel

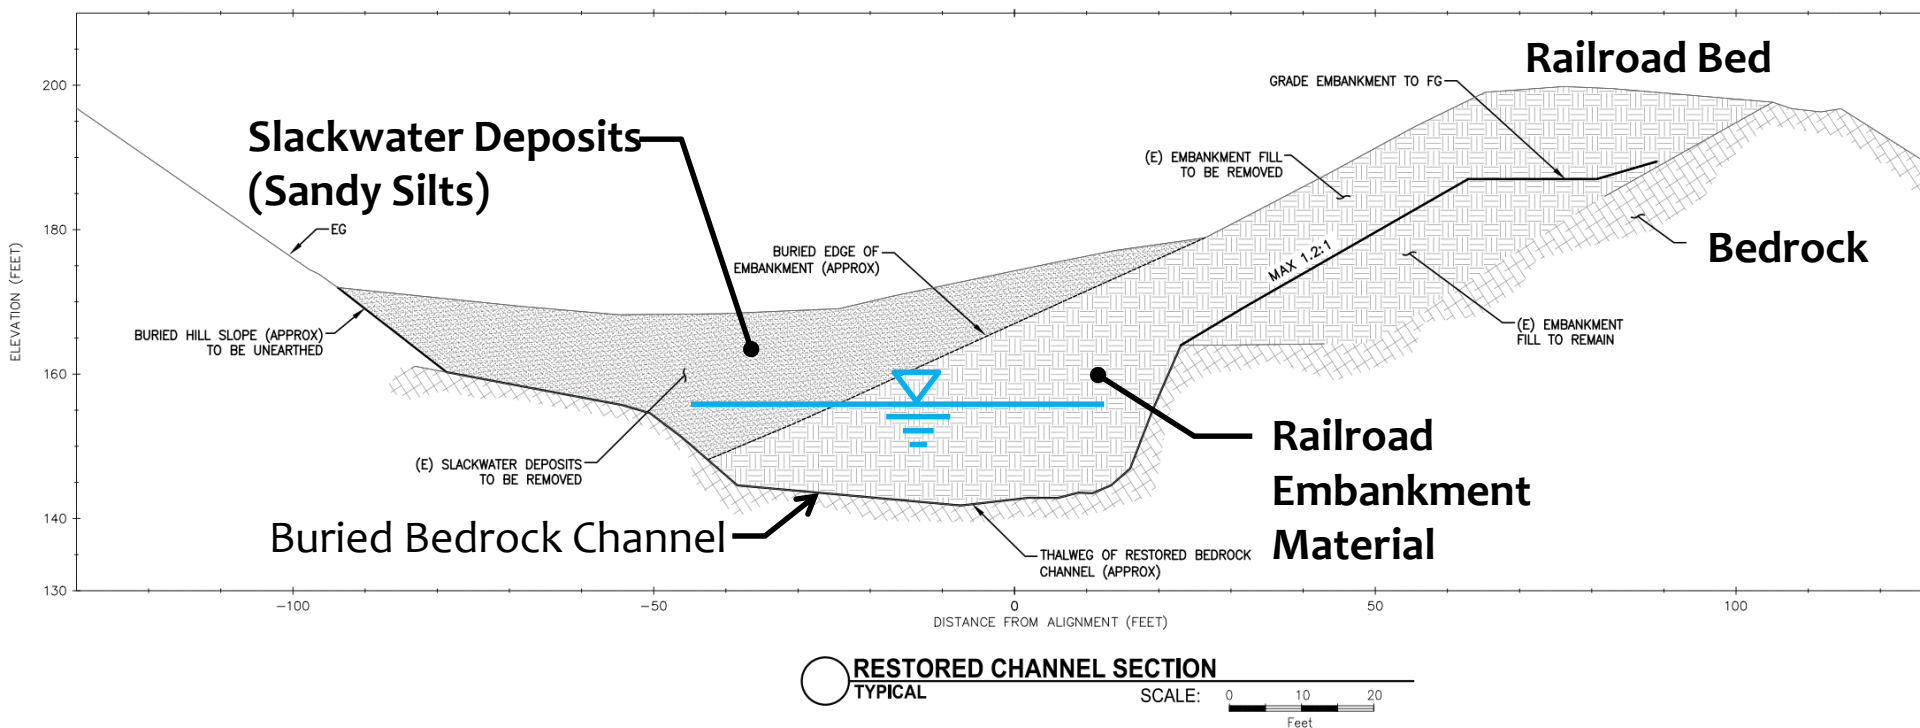
# Typical Section of Soil Types Based on Geologic Investigation

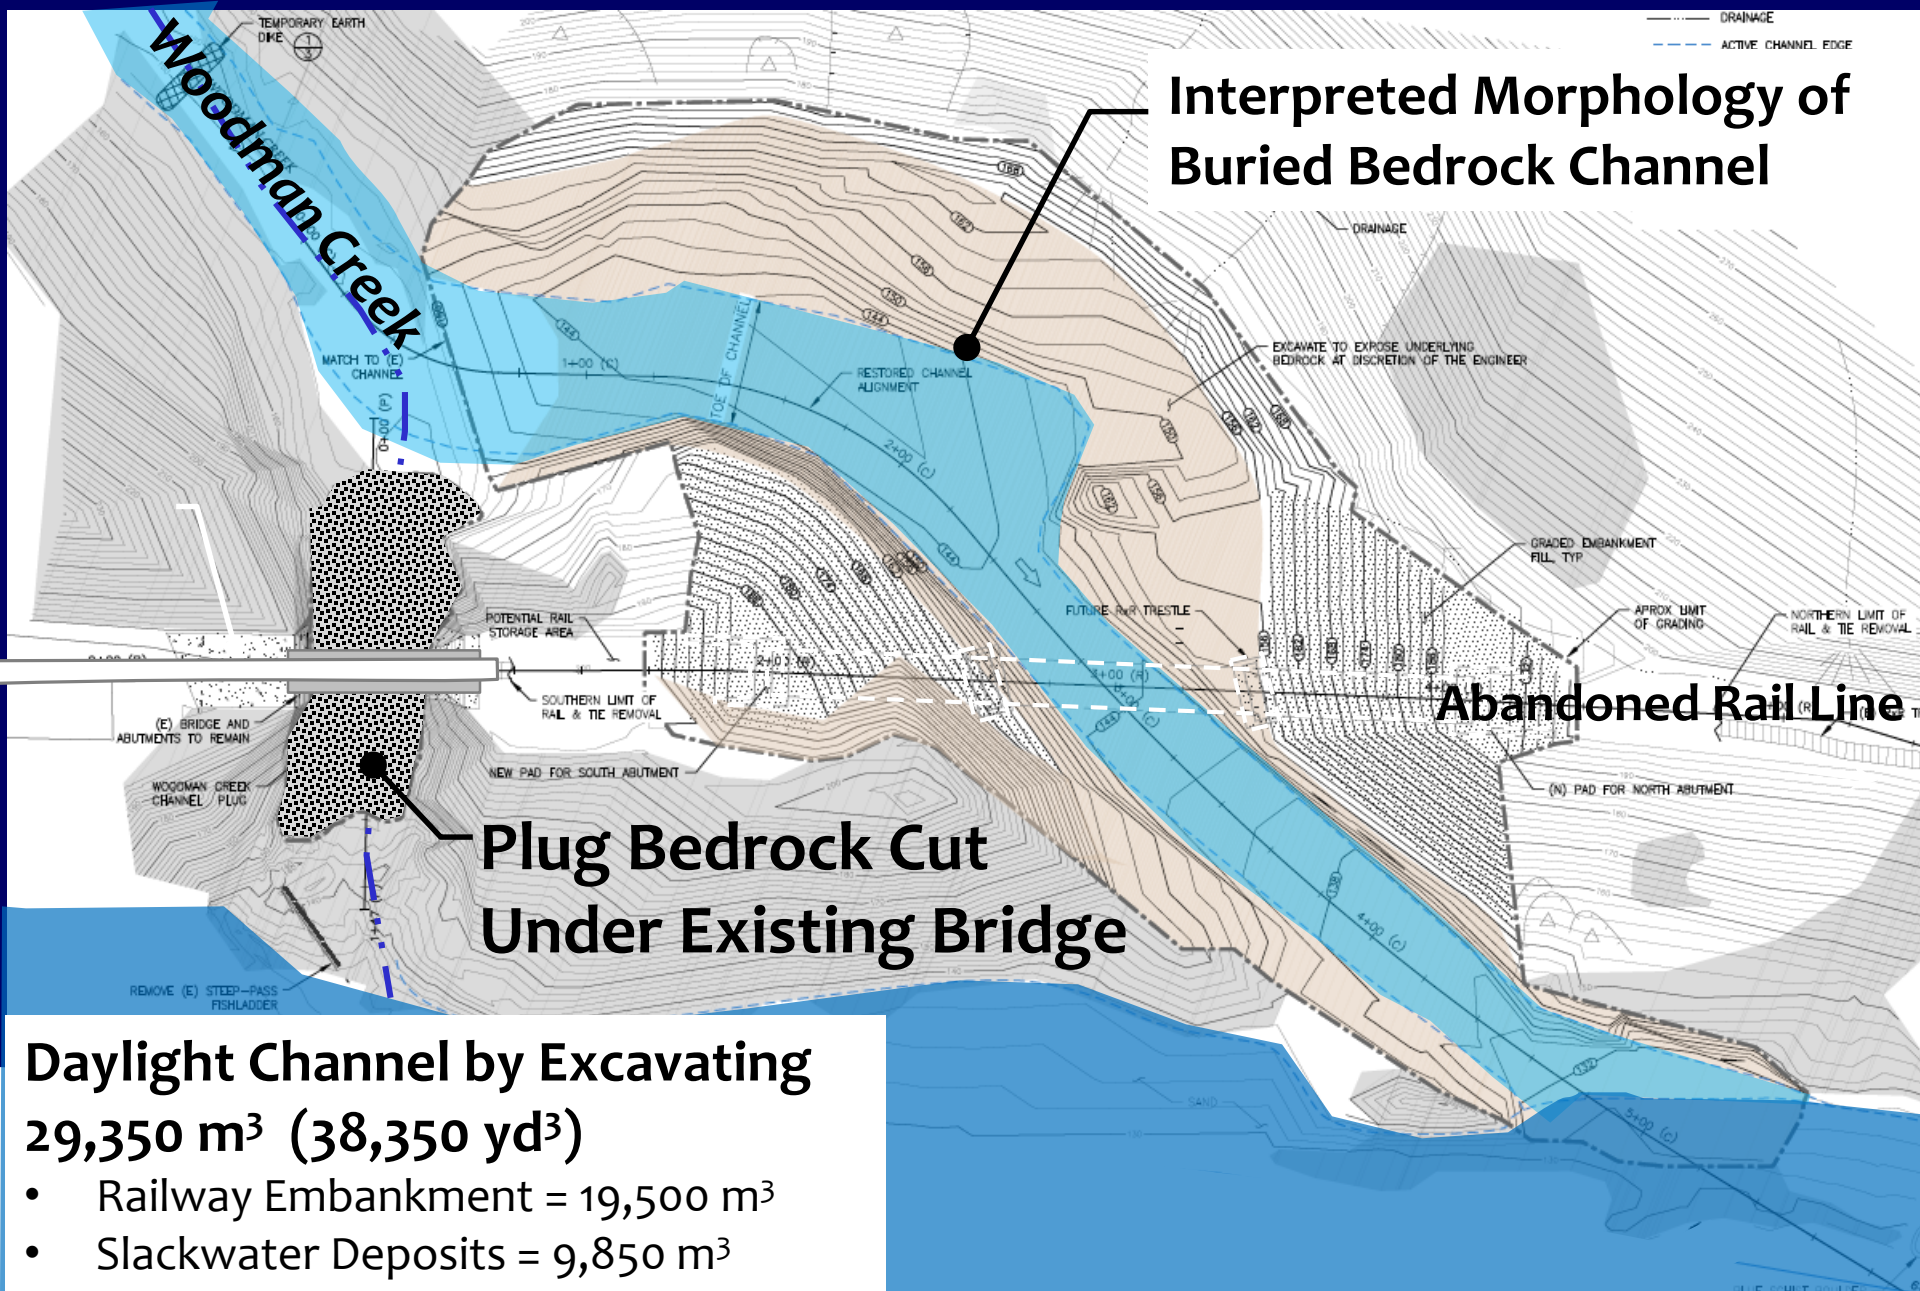
# Developed Surface Model of Buried Channel

**Daylight Channel by Excavating  
29,350 m<sup>3</sup> (38,350 yd<sup>3</sup>)**

- Railway Embankment = 19,500 m<sup>3</sup>
- Slackwater Deposits = 9,850 m<sup>3</sup>

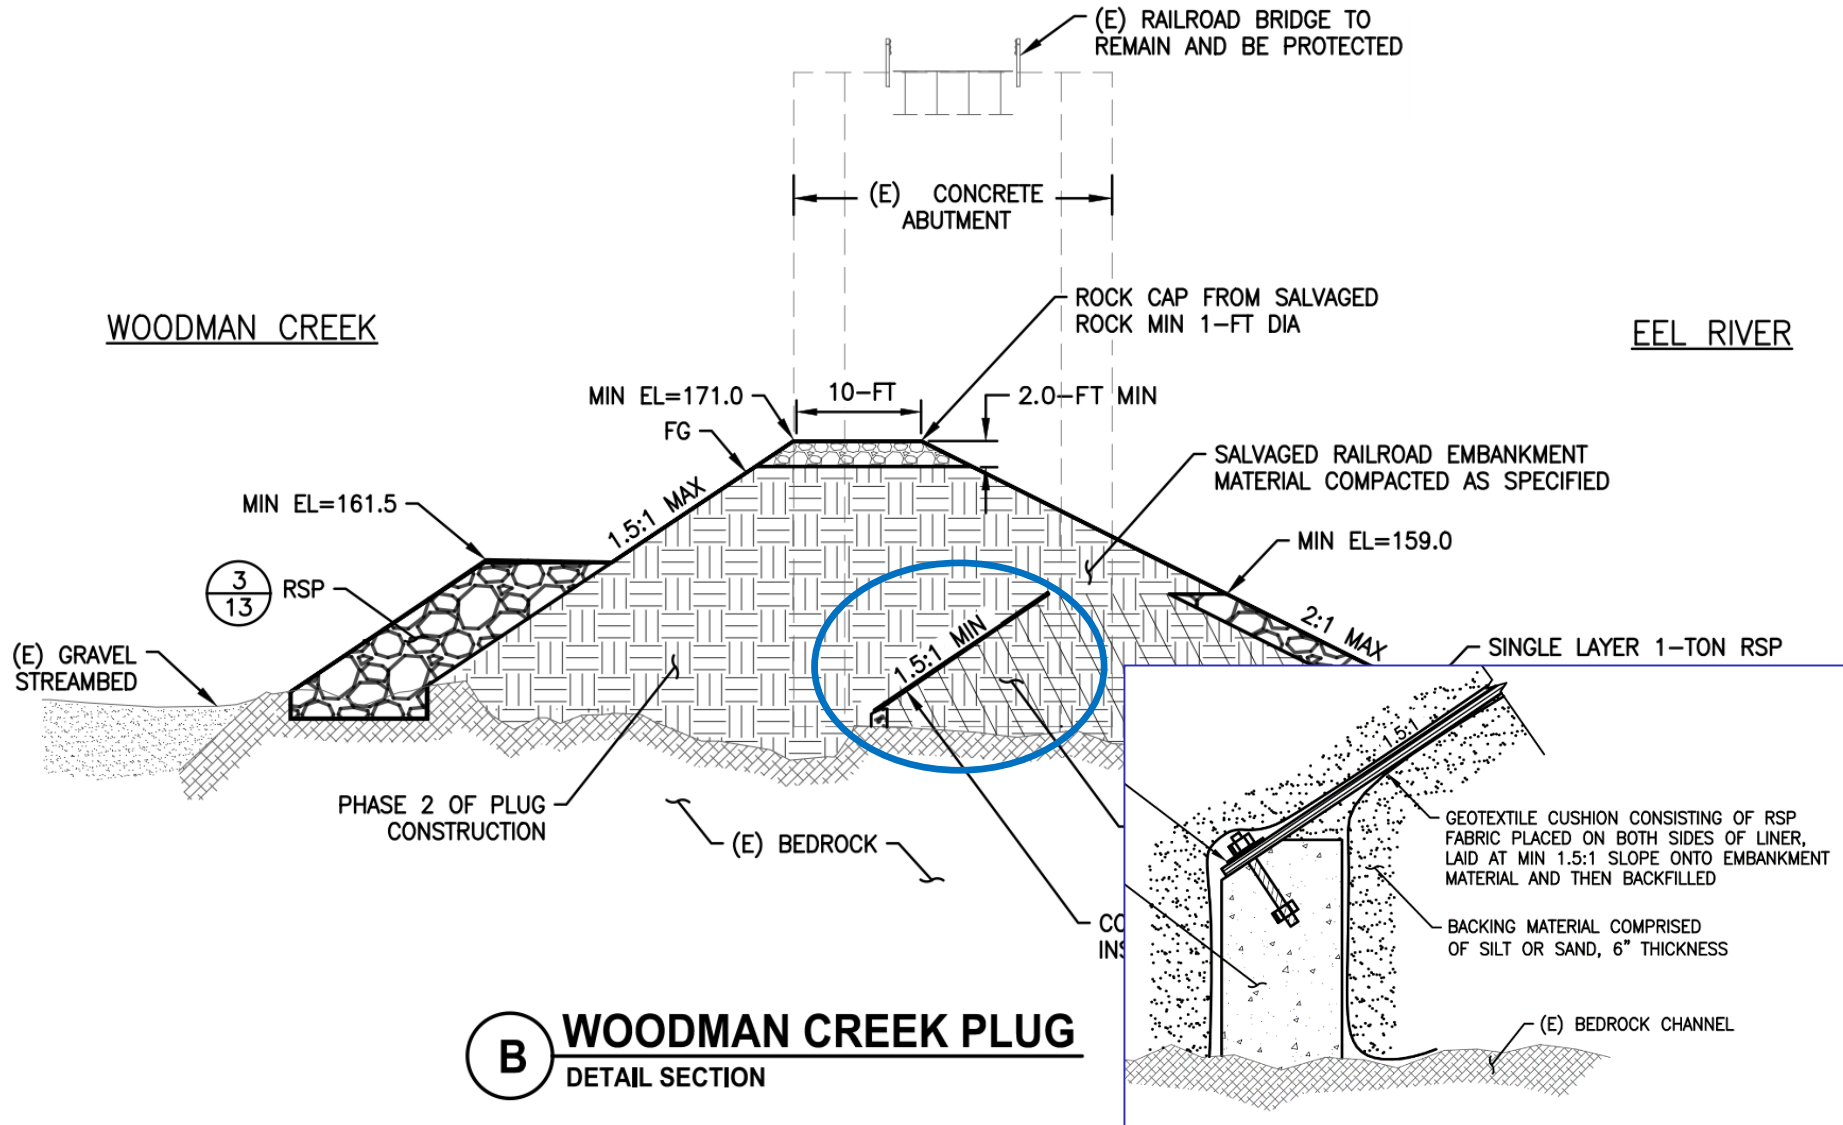
# Design of the Channel Plug

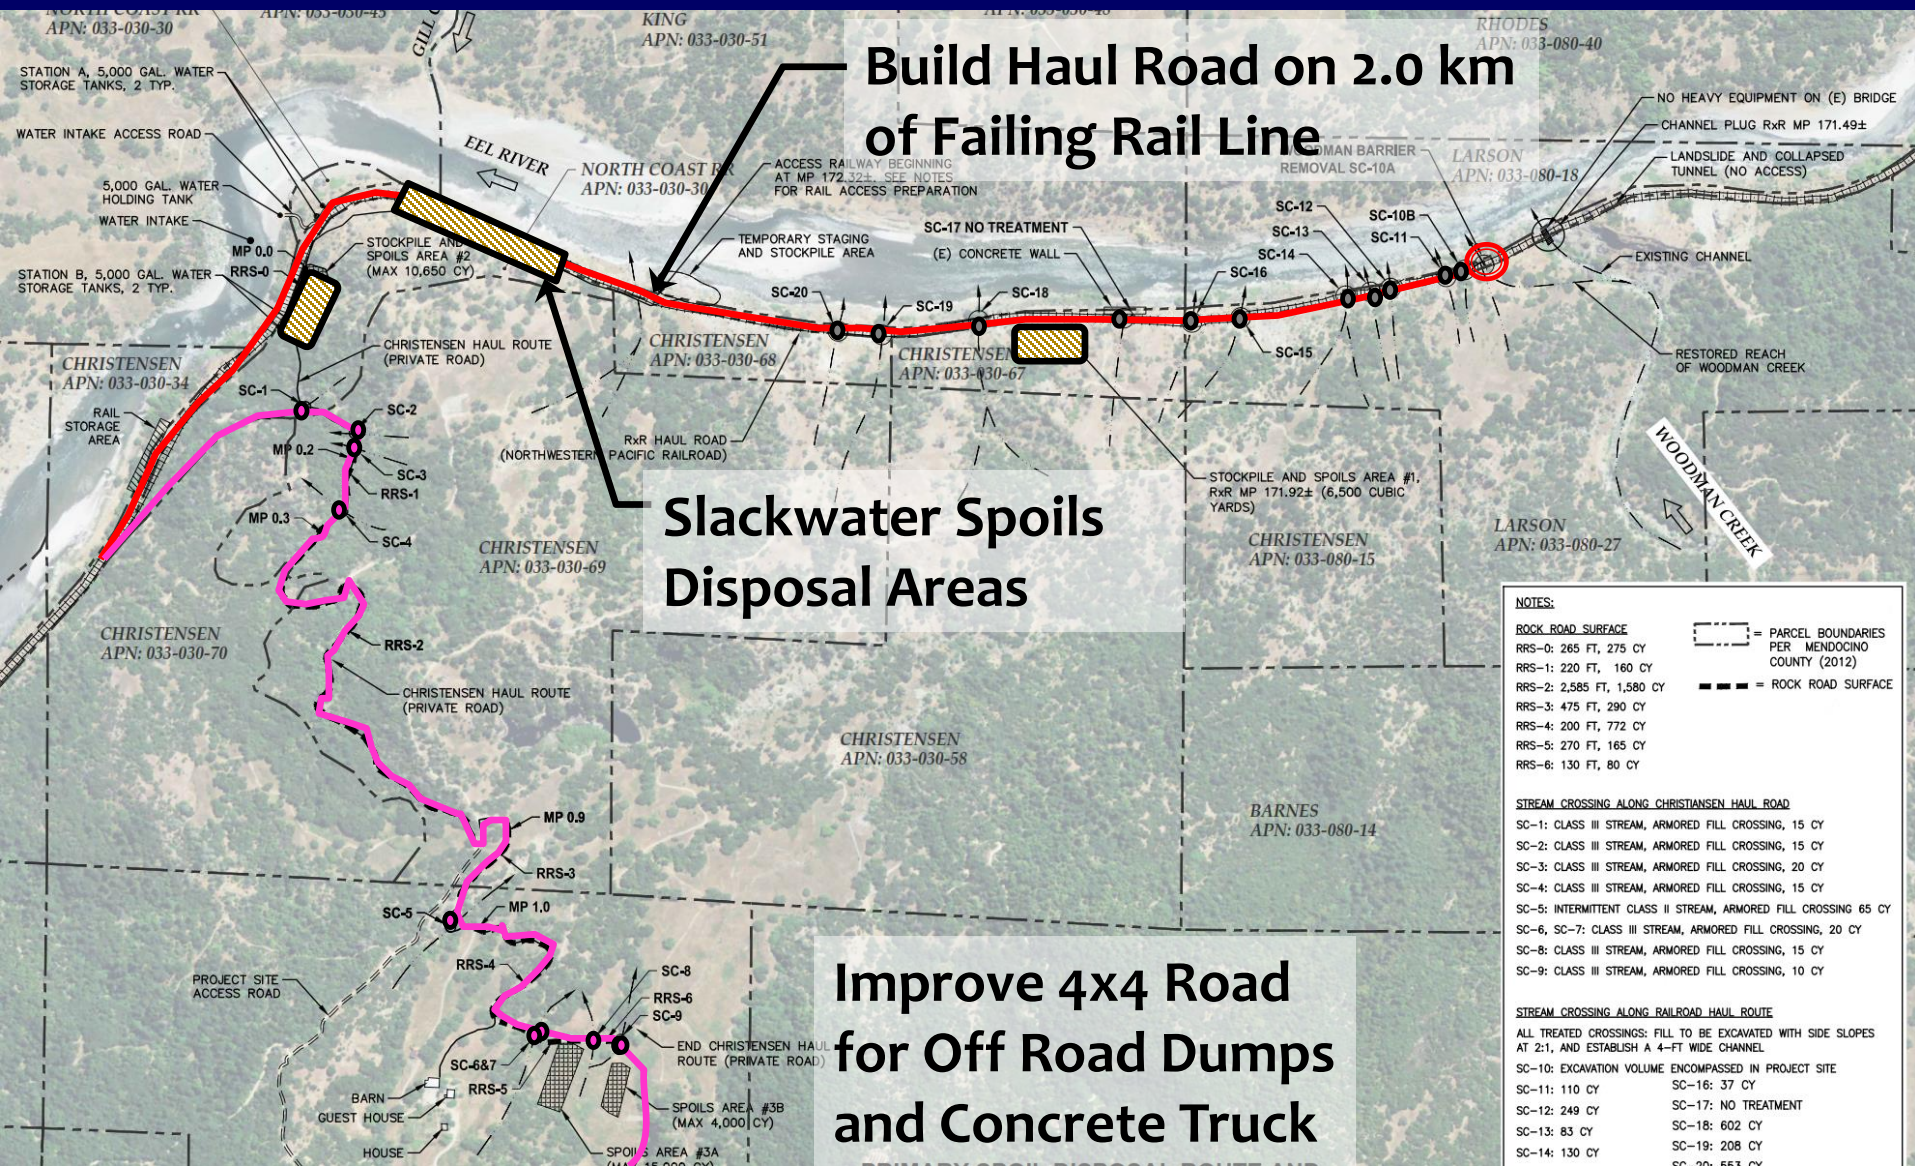
# Site Access and Spoils Disposal

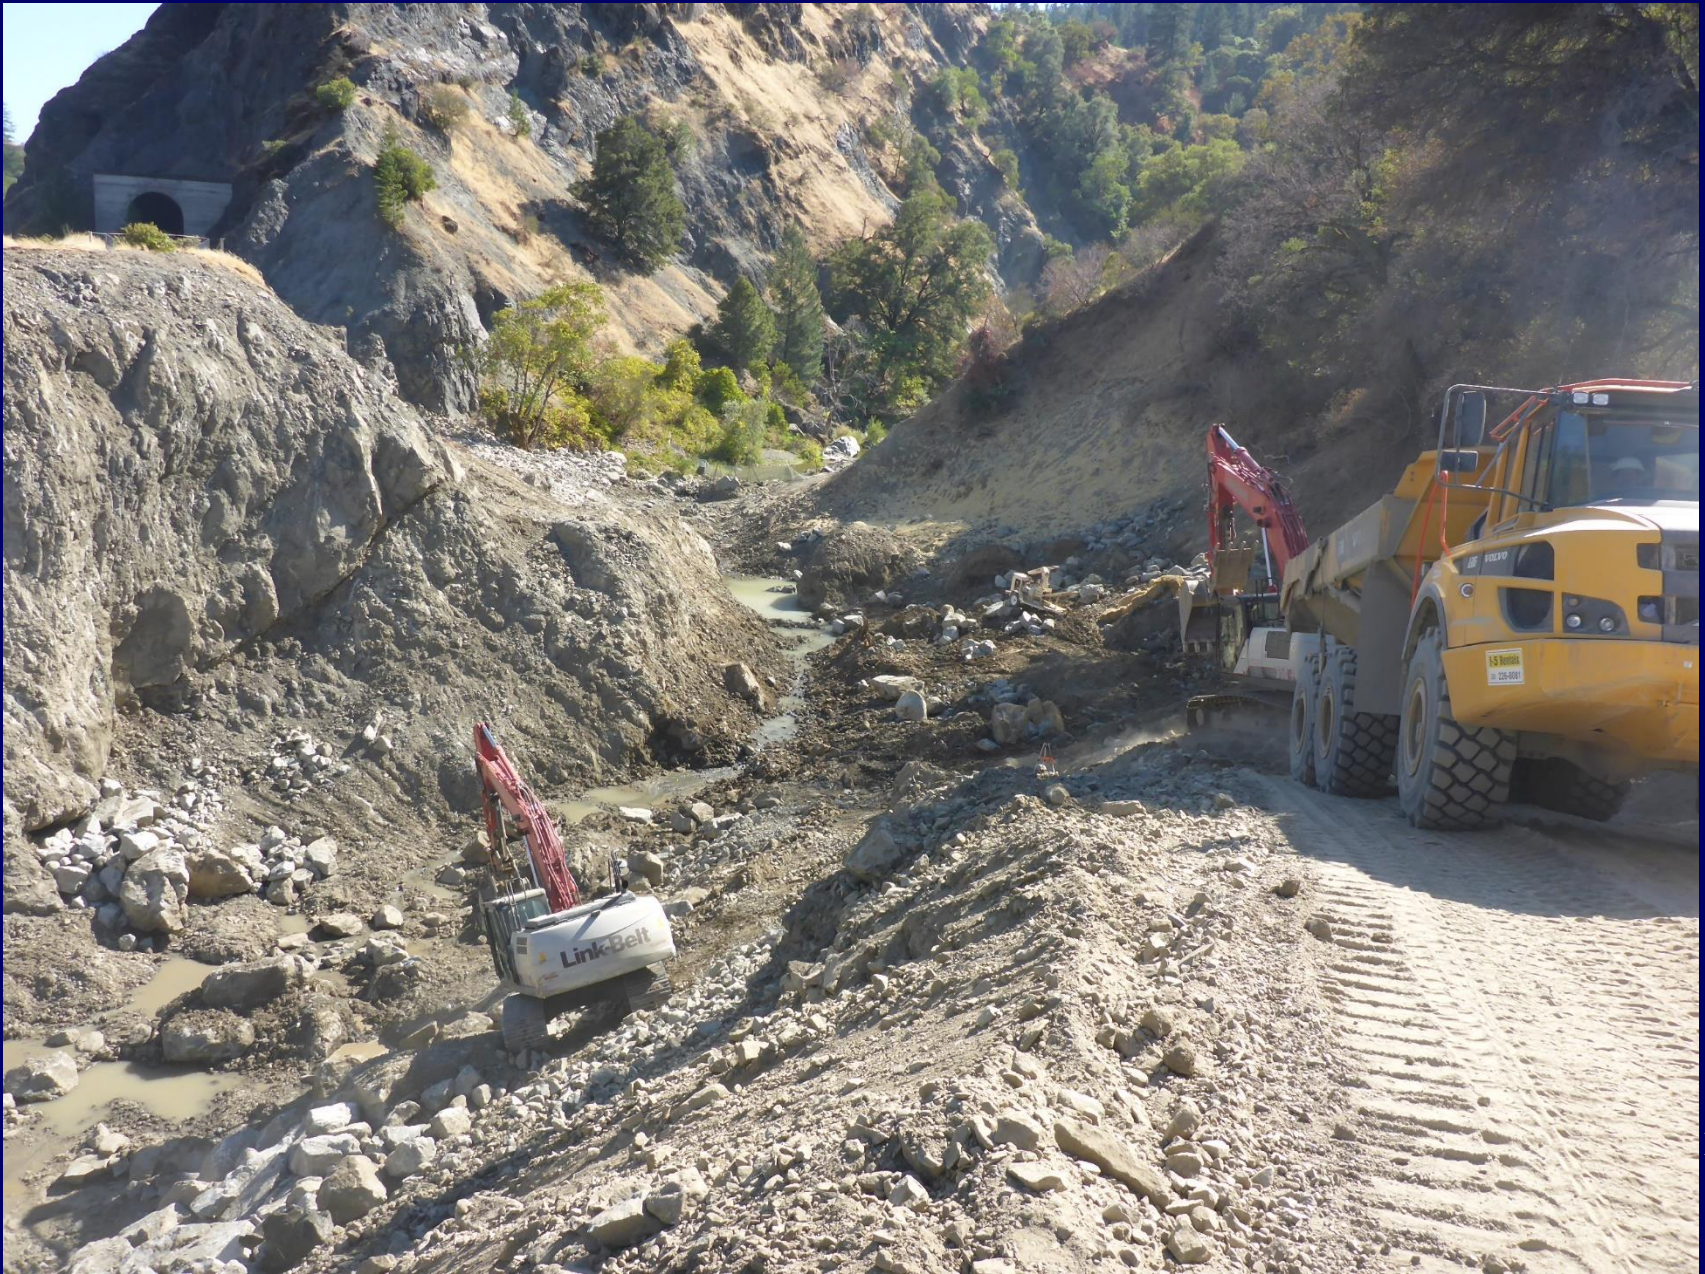
# Daylighting the Buried Channel

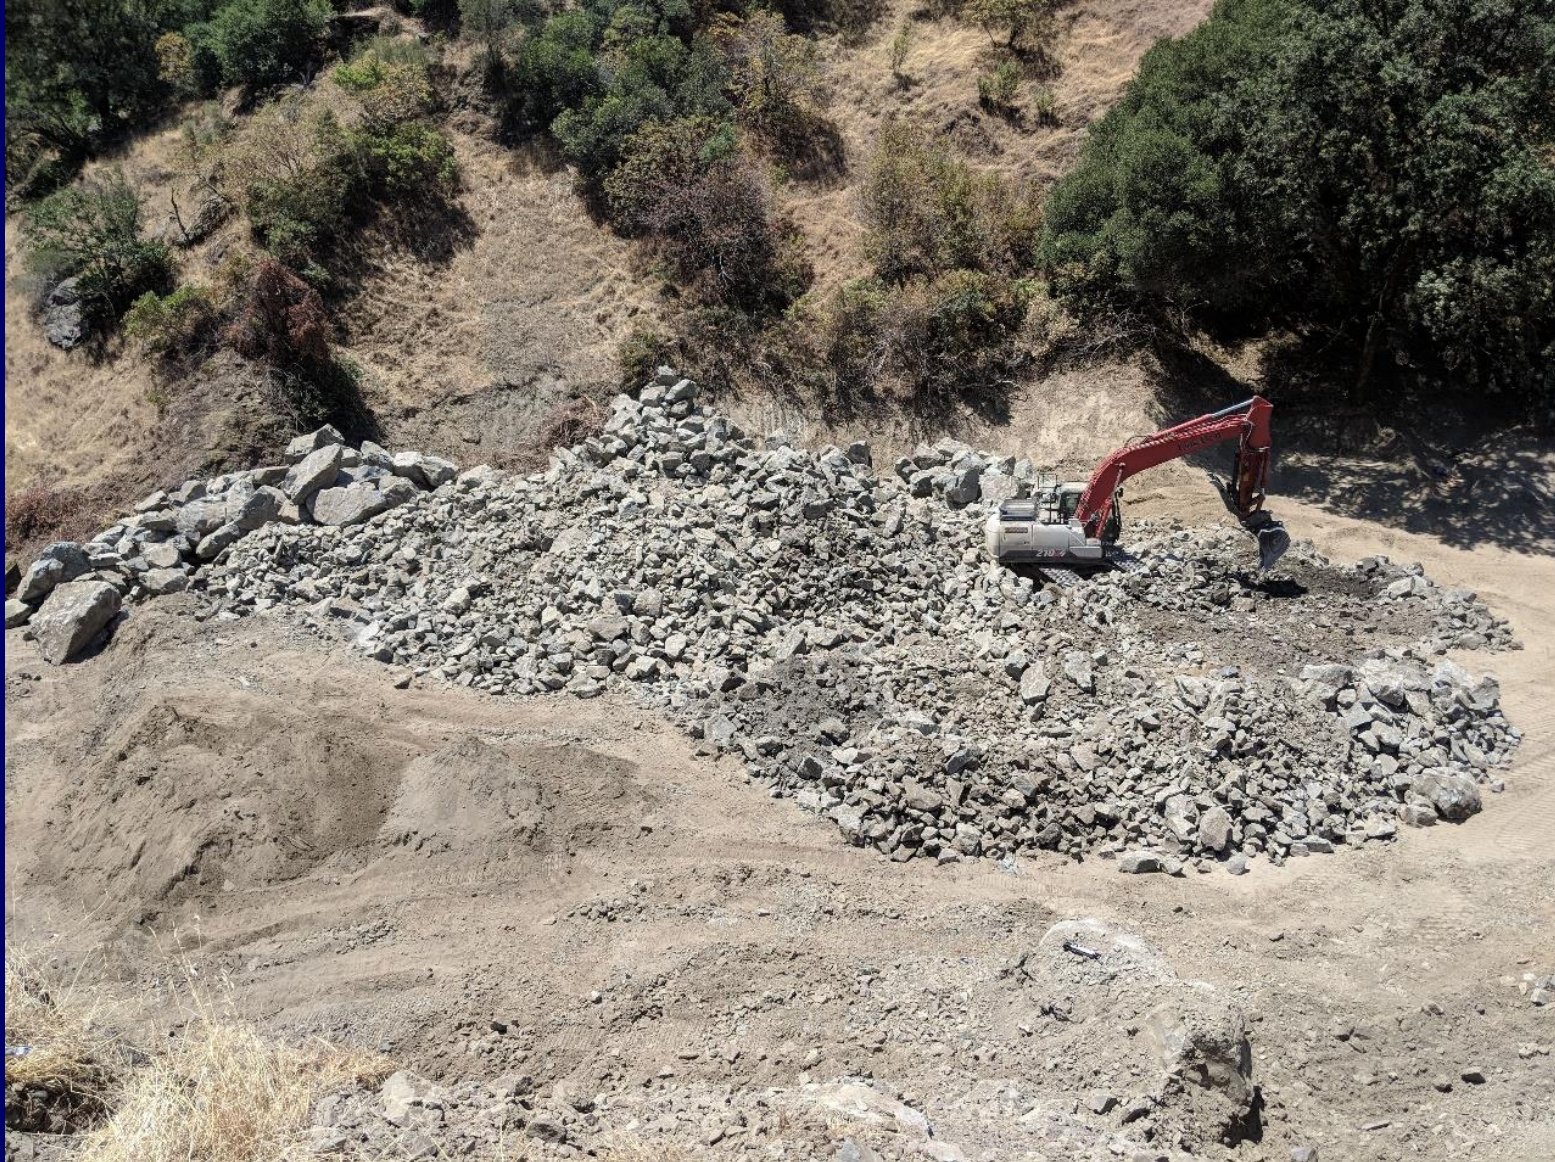
# Salvaged Rock from Embankment Material for Plugging the Bedrock Cut

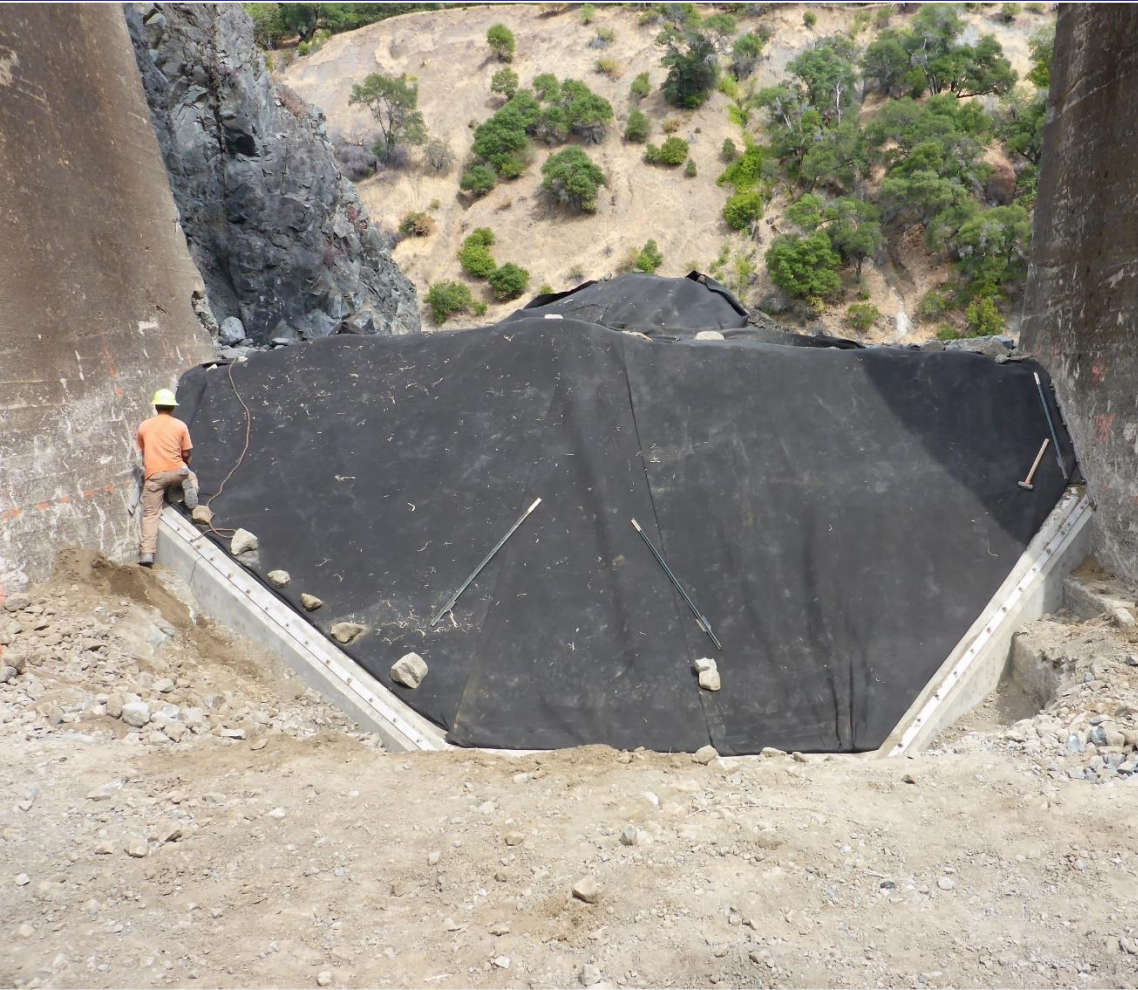
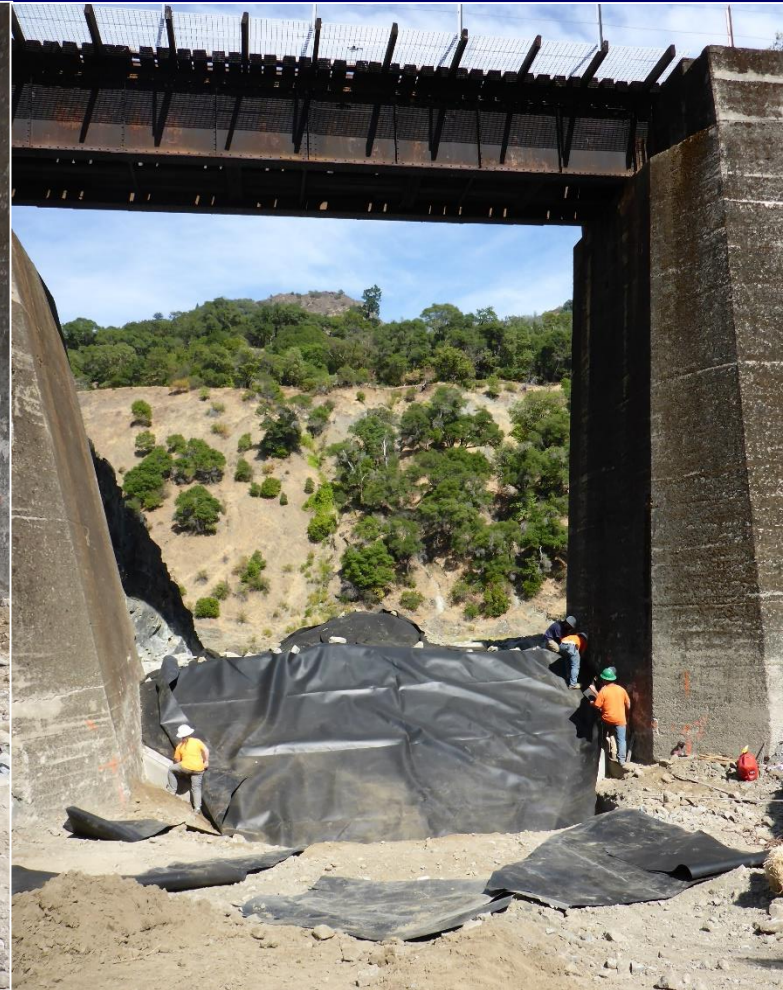
# Setting Geomembrane Liner for Plug
